Raasay House

A Photographic Record 2008

Report No.	HAS080902
Project code	RHS08
Client	ROK Prime Contracting
Date / updated	11 February 2009
Author	John Wood

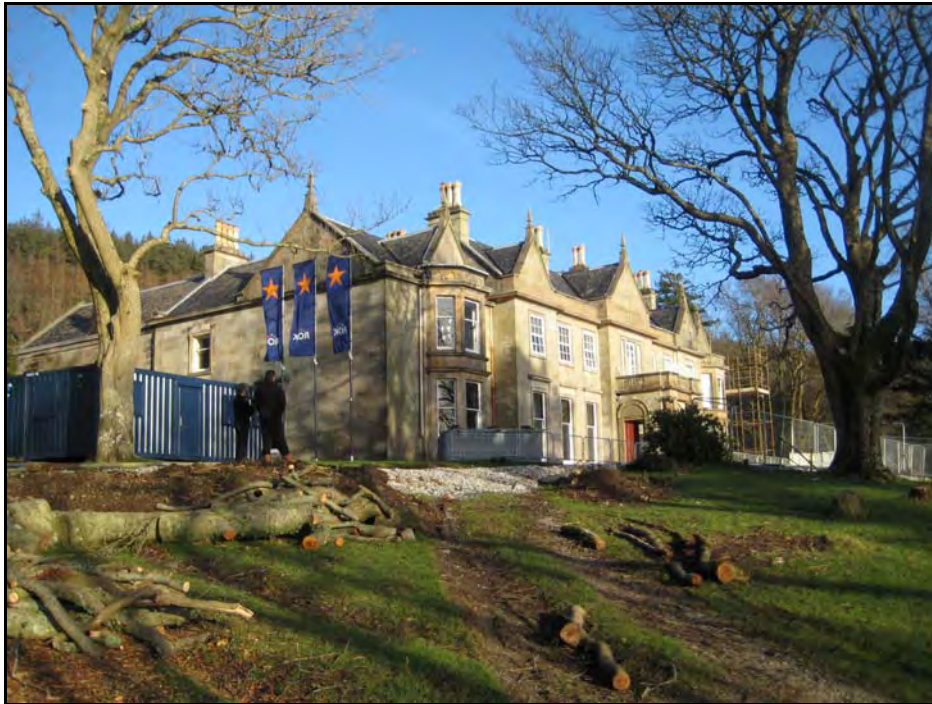
Plate 3 Raasay House in February 2008
(ROK)

The renovation project required considerable work, including re-roofing, replacing leadwork and some lintels, and tying in stonework. On completion the intention was for Raasay Outdoor Centre to take a new lease on the building, with the aim of offering courses and activities on a year round basis and creating full time employment opportunities for young people on the island. The rent would be used to support and develop social and economic initiatives on the island and give Raasay House a new lease of life in the 21st c. However a week before it was due to be handed over by the contractor, it was largely destroyed by a major fire, which has left a burnt-out shell. It was a devastating blow to all concerned.
